**Observation Report  
of the  
Electrical services  
for  
Turtle Cove Condominium Association  
1213 Linda Road, Okeechobee, Florida 34974**

**Issued: February 17, 2026**

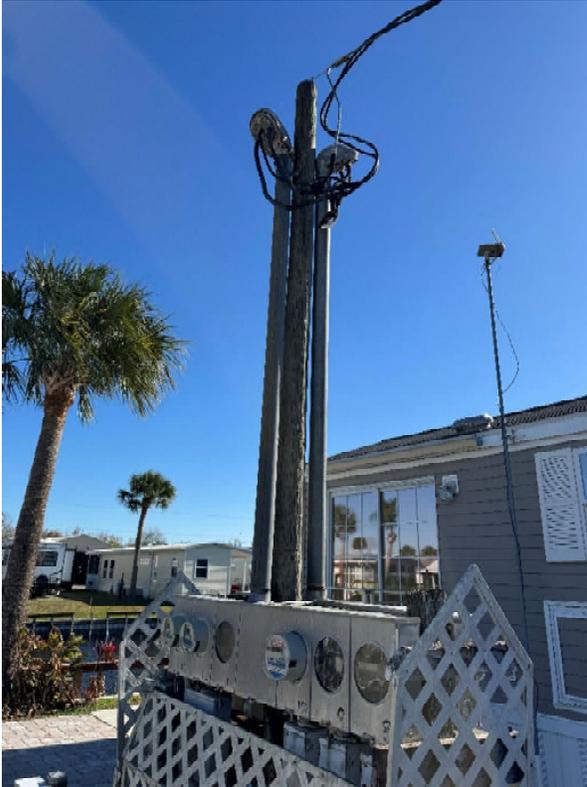
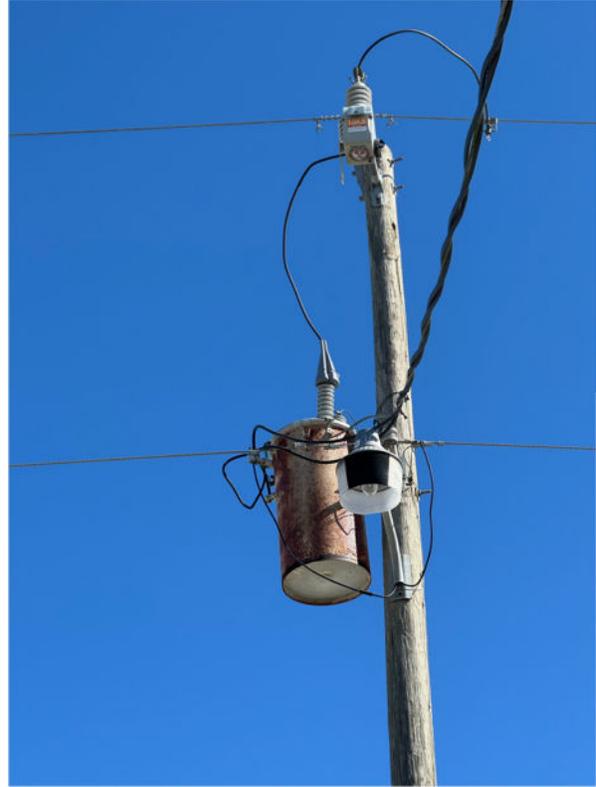
- 1. Observation:** Each overhead service feeds anywhere from 9 – 12 individual meters and mains that then feed underground to each lot.

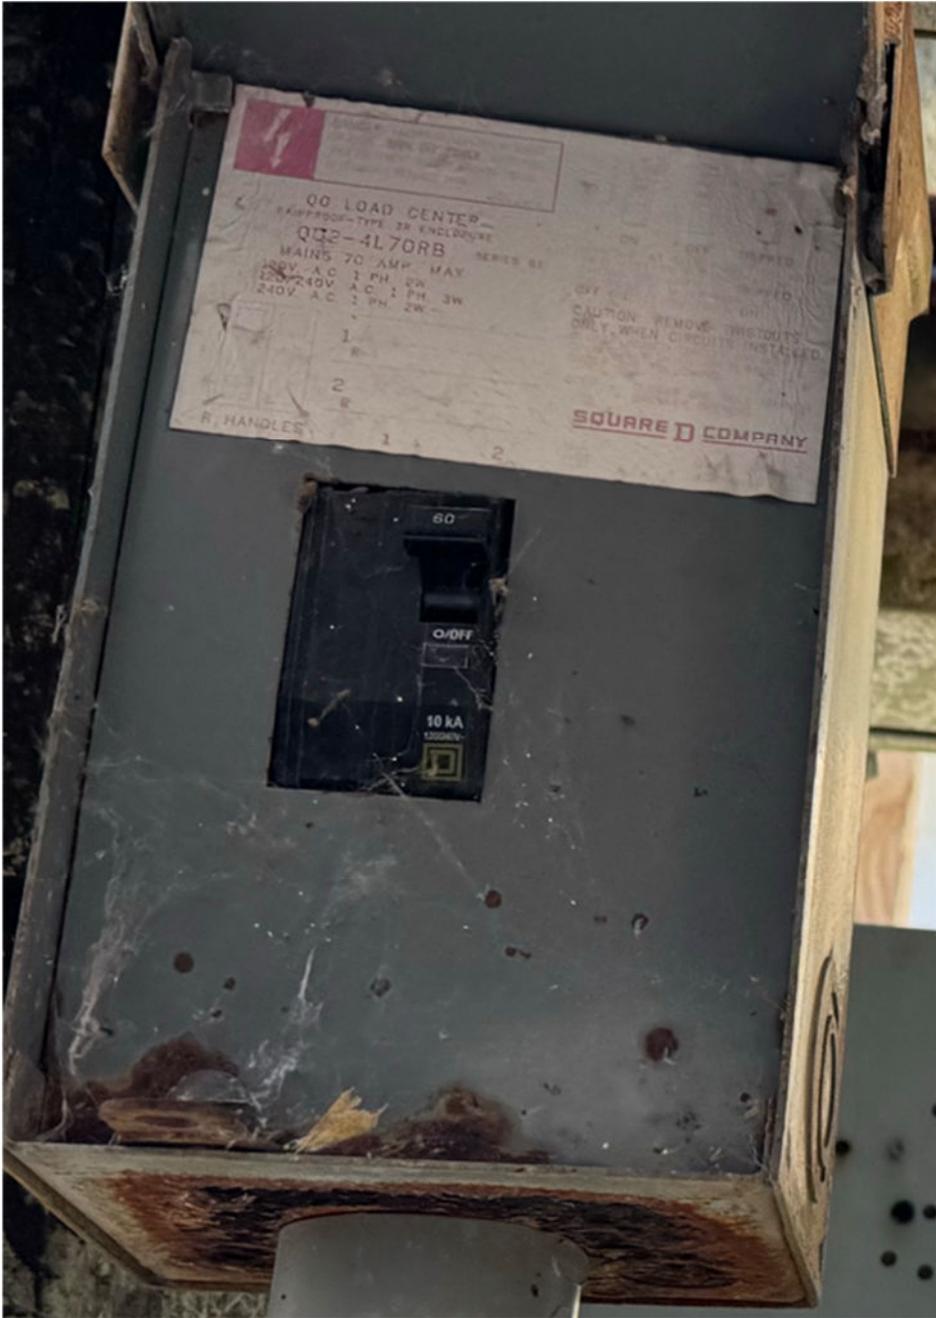
- 2. Observation:** Each lot was originally fed with a 60-amp breaker, 120/240v single-phase service to a plug located on each lot. (Breaker box rated for a maximum of 70 amps)

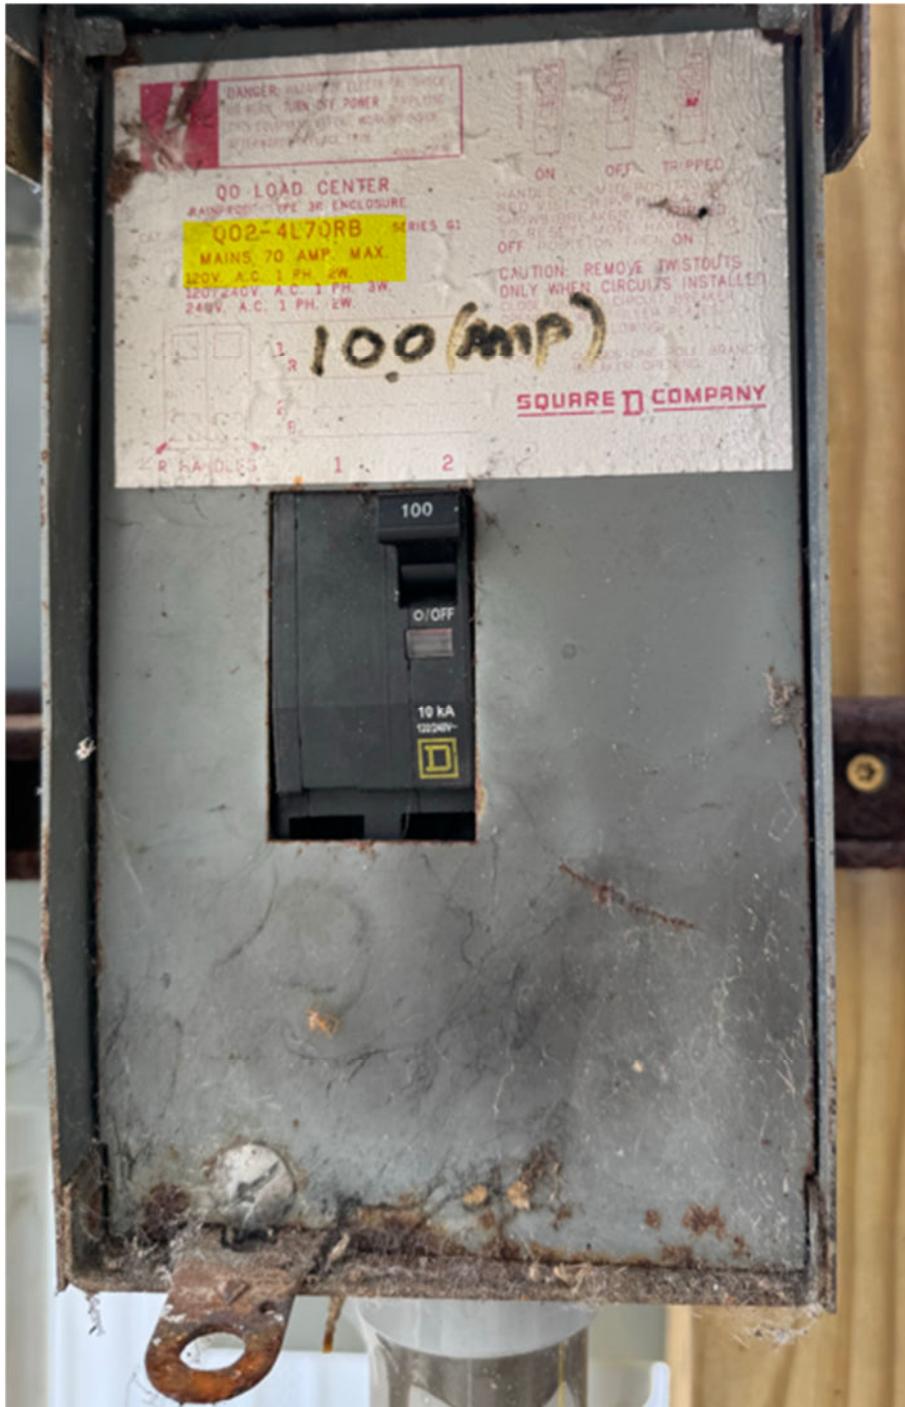
4. **Observation:** Many of the original 60-amp breakers have been switched out for larger 100-amp breakers. These exceed the rating of the breaker box and the #6 wire. Breakers shall not exceed conductor ampacity per NEC 240.4. Also violates panel labeling/max rating (70 A noted). Immediate hazard per NEC 110.3(B) (listed equipment use).

**Recommendation:** Replace these with 60-amp breakers immediately.

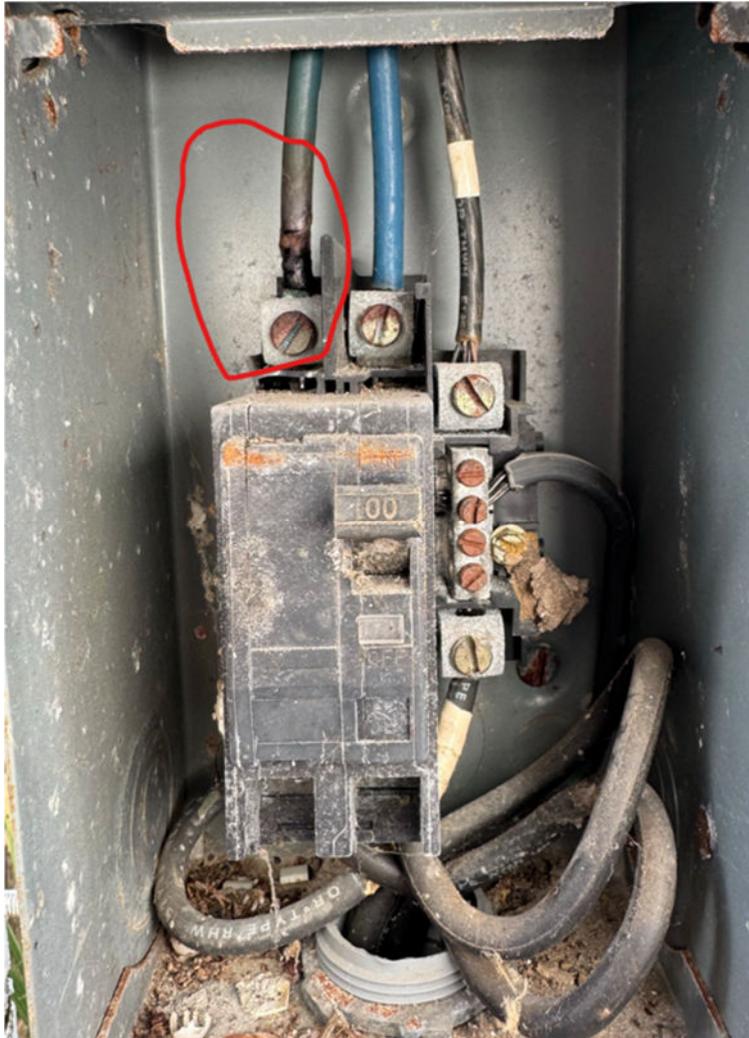
5. **Observation:** Evidence of thermal damage indicates high-resistance terminations or overload.

**Recommendation:** Recommend an infrared scan (if not already done) and replacement per NEC 110.14 (electrical connections) and NEC 110.12 (neat/workmanlike).

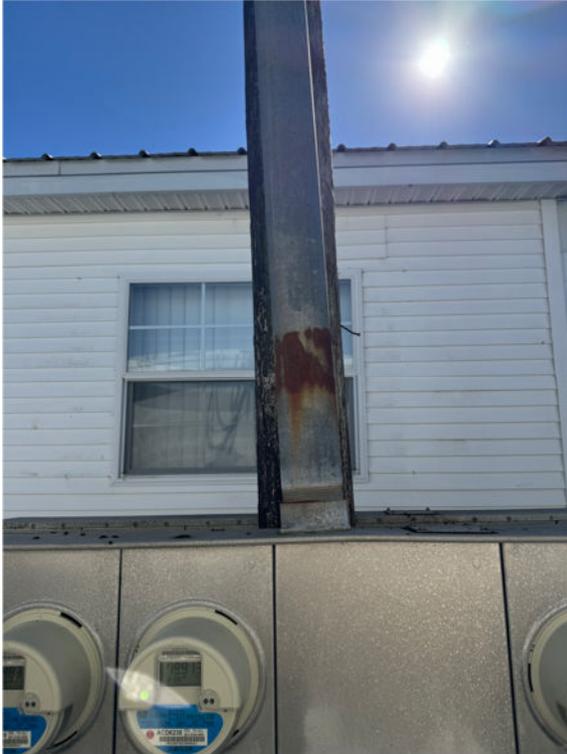
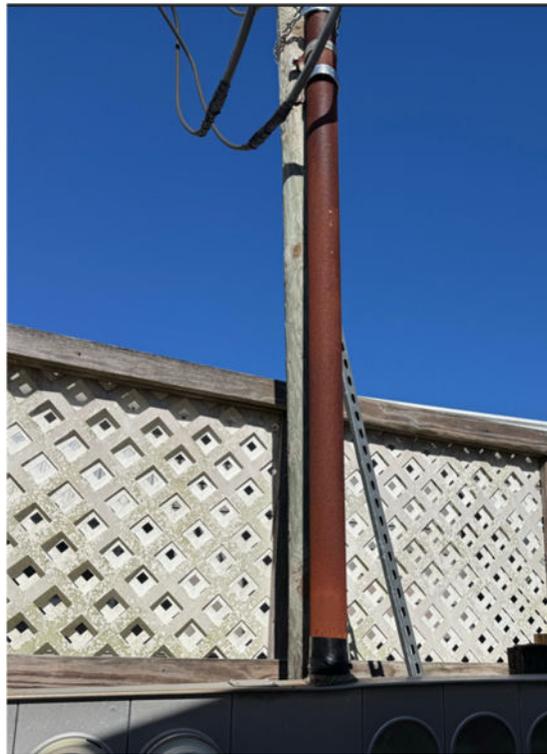
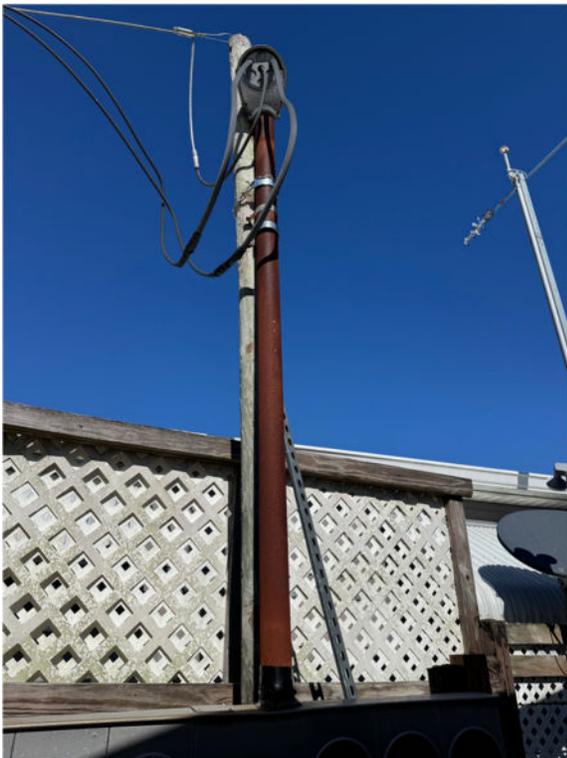
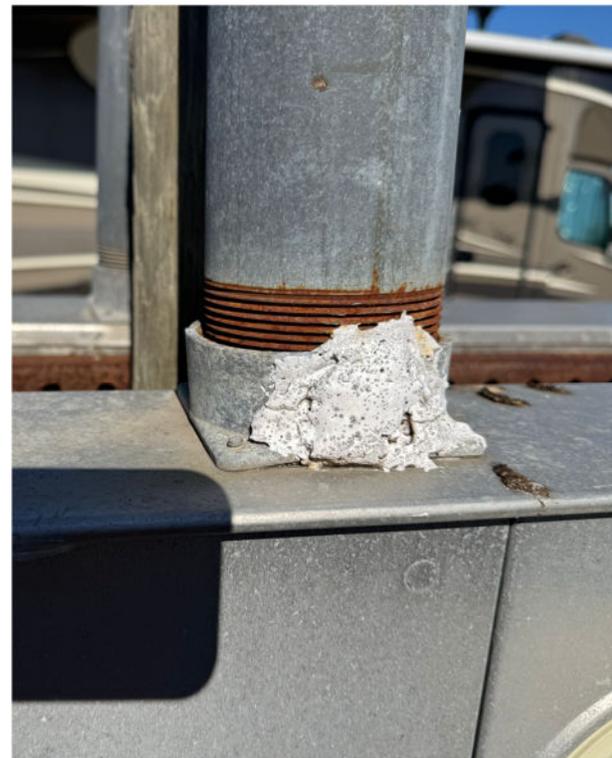
6. **Observation:** Some weather head masts are under strain from overhead lines. Causing bending, flexing, and damage to the threaded connection to the meter cans. Weather head strain risks conductor damage/failure per NEC 230.28 (service masts).

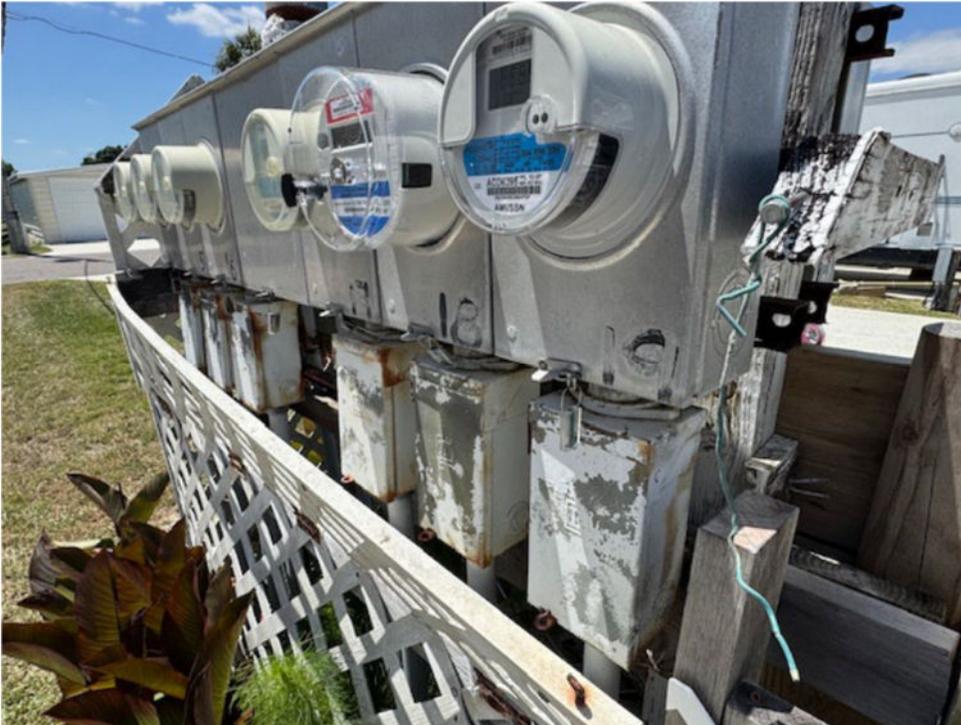
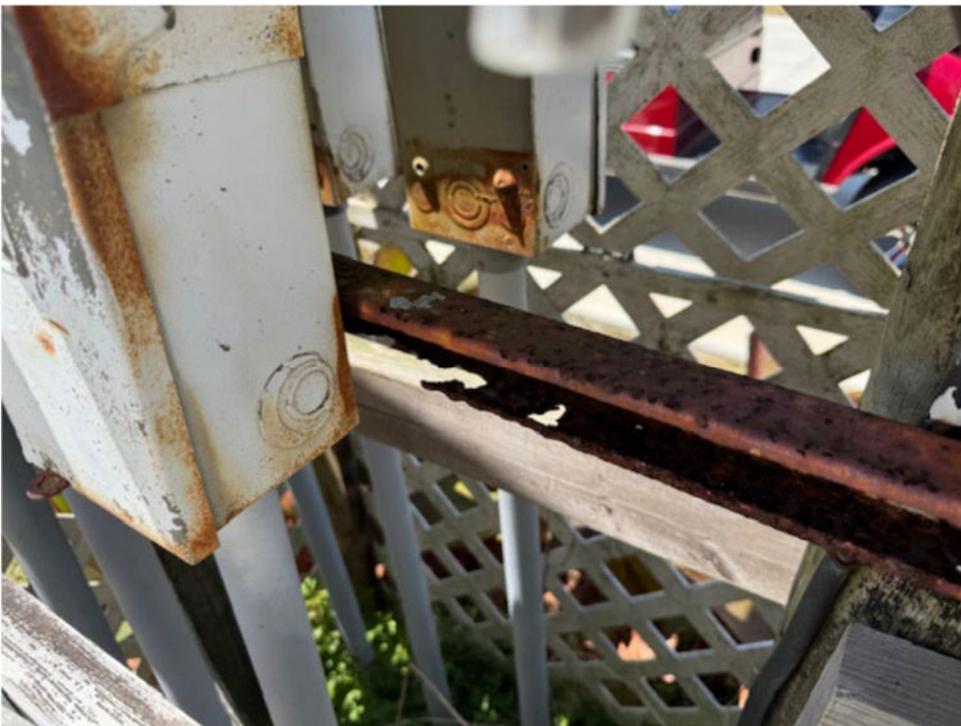
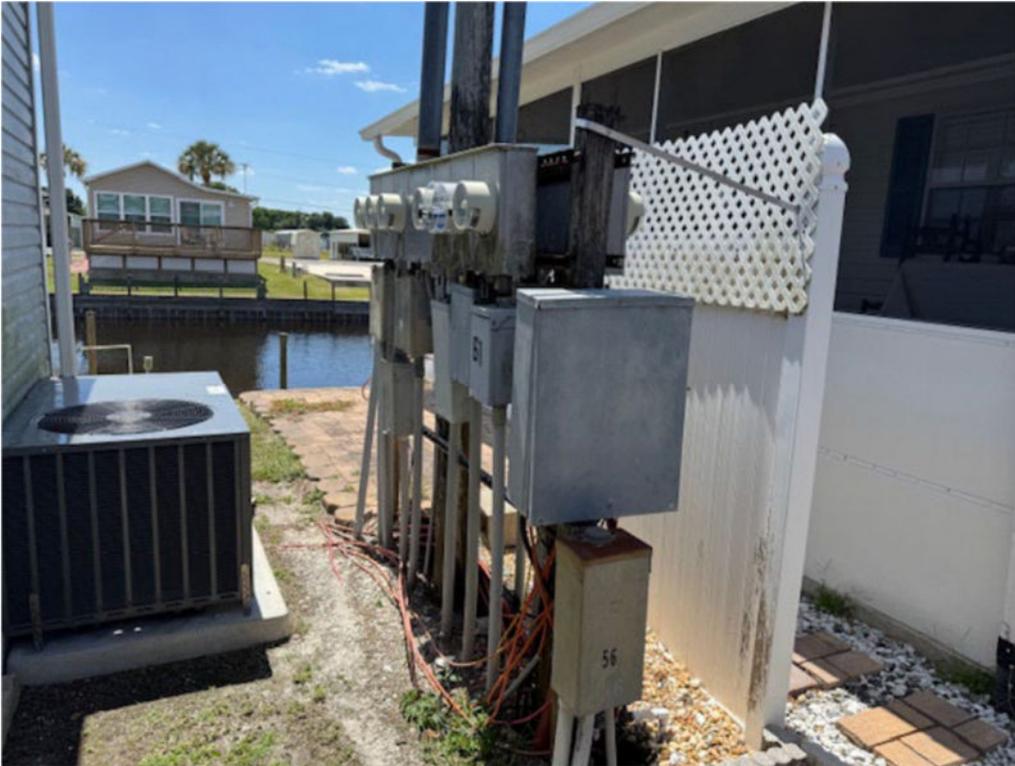
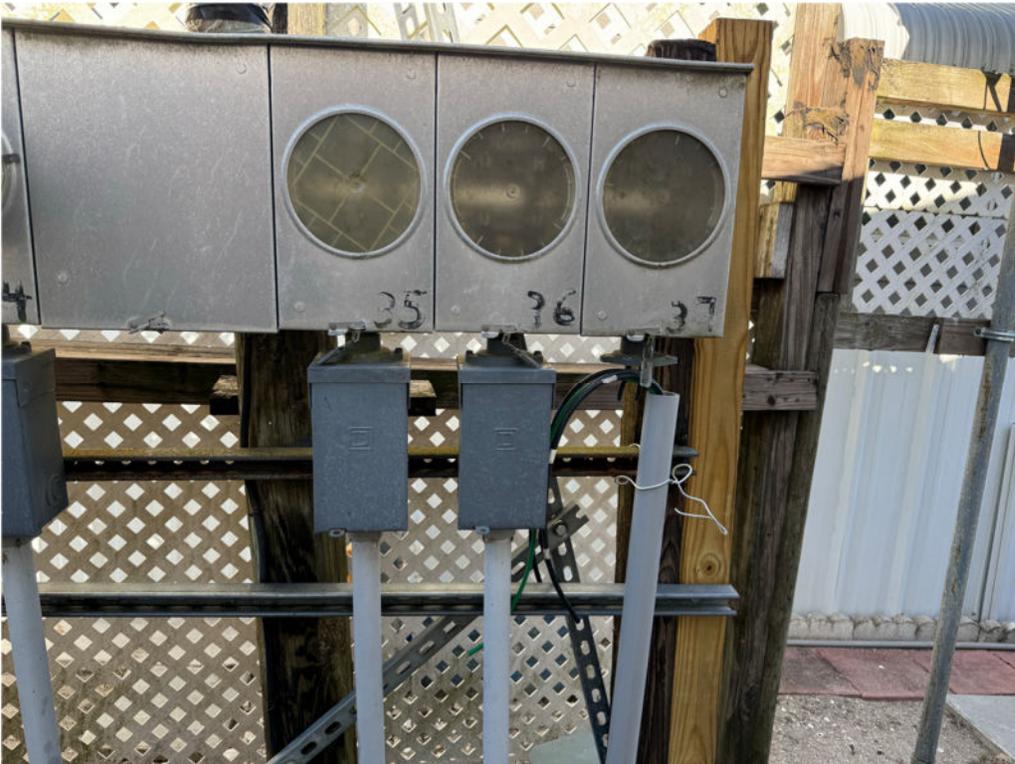
- 7. Observation:** Meters and mains are mounted on stanchions constructed of wood and steel Unistrut. Wood stanchions, masts, and Unistrut are in varying degrees of disrepair. Many have been jerry-rigged in an attempt to secure the structures. Jerry-rigged supports violate NEC 110.12.

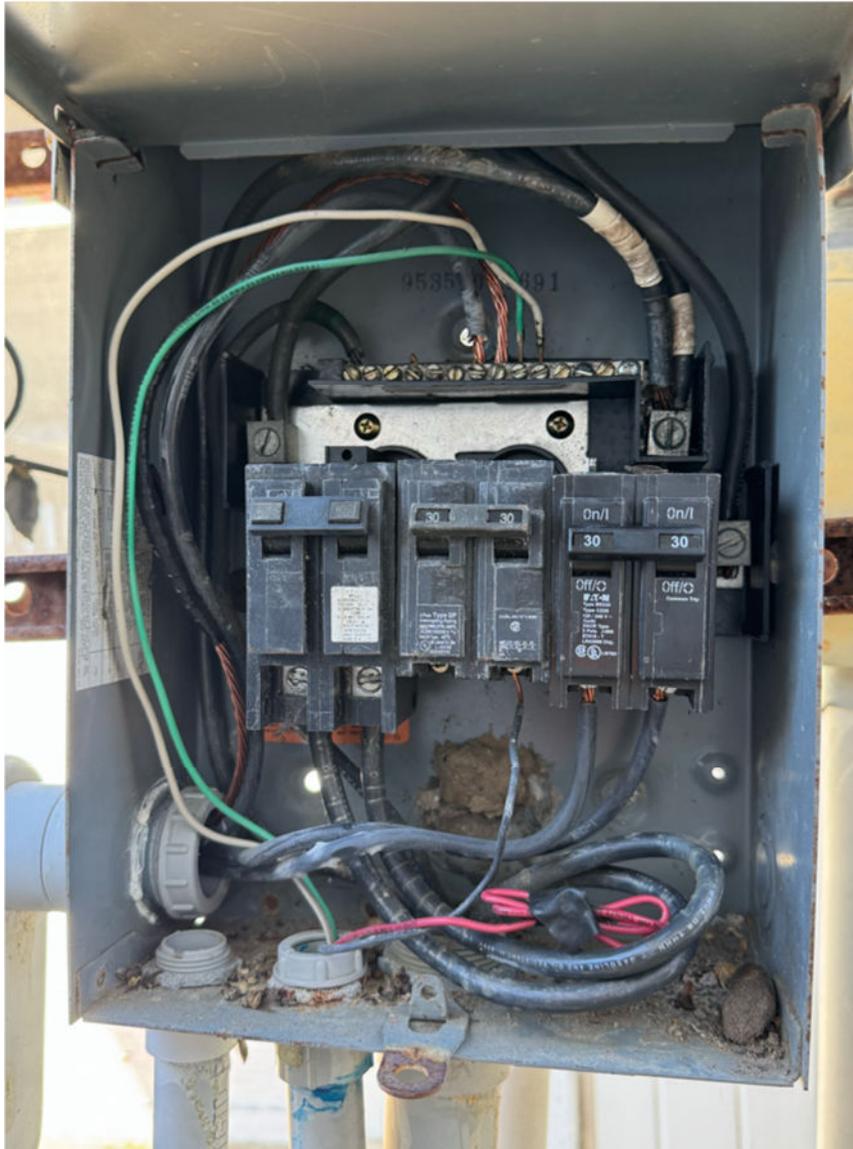
- 8. Observation:** Some mains have been replaced with sub-panels with multiple breakers. The panel below has an undersized wire (#14) connected to a two-pole breaker (30-amps). #14 AWG on 30 A breaker violates NEC 240.4(D) (small conductor rule: #14 copper max 15 A) and NEC 240.4.

**Recommendation:** Replace the breaker with the correct size.
